Test Report No. 7191122284-MEC15/2-YWA
dated 12 Oct 2015
(221406488)

Fire propagation test on "CMAX" Mineral Fiber Ceiling material submitted by KW-JWEE Marketing Sdn Bhd on 16 Sep 2015.

To determine the Index of Performance of the material when it is exposed to the conditions of the test specified in British Standard 476 : Part 6 : 1989 + A1 : 2009 "Method of test for fire propagation for products".

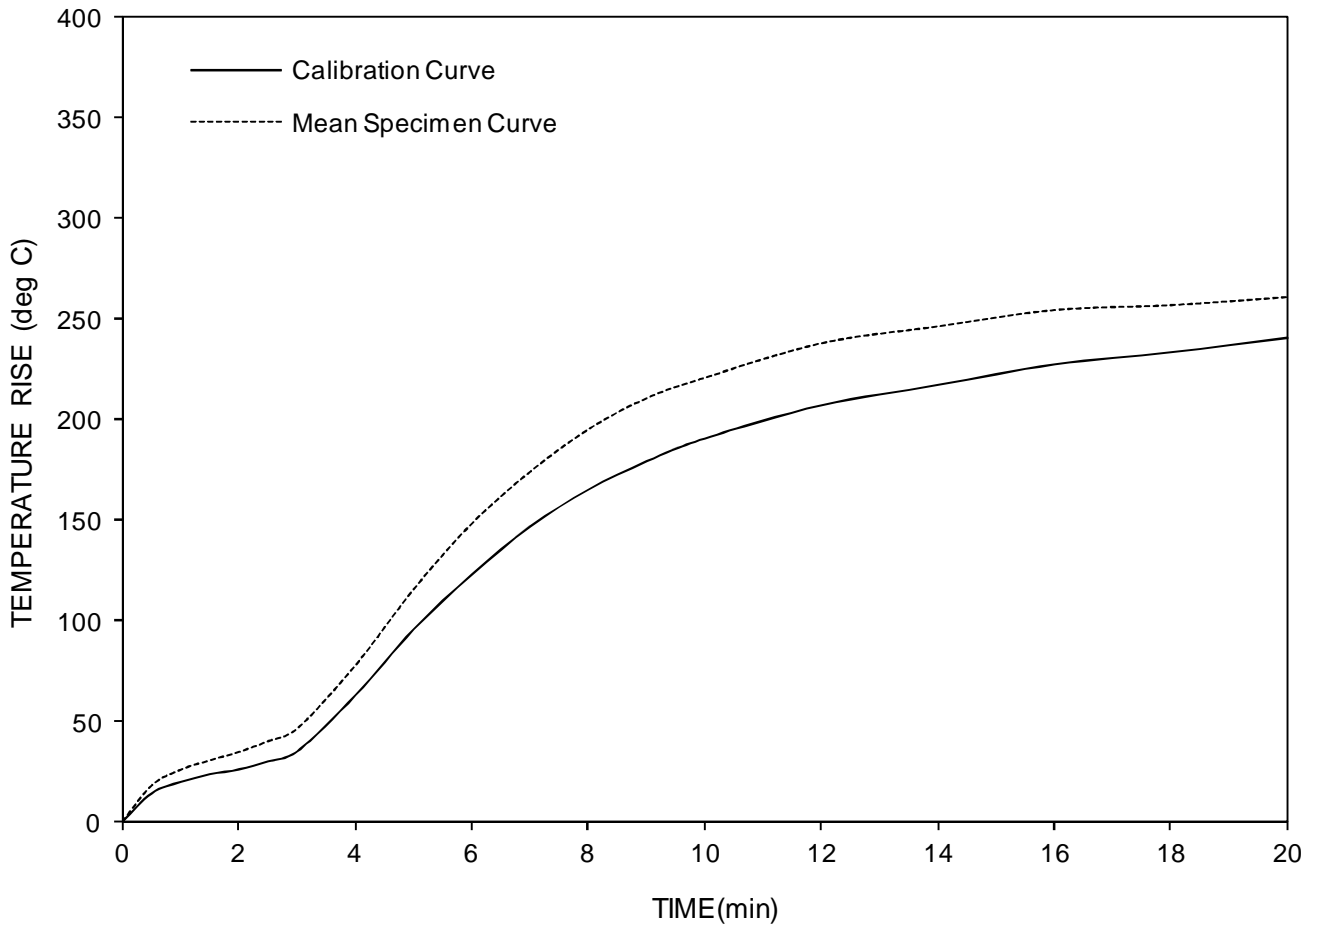
FIGURE 1 : COMPARISON OF MEAN SPECIMEN AND CALIBRATION CURVES

The calibration and test procedures were as defined in paragraphs 8 and 9, respectively, of the specification. The apparatus was calibrated prior to test and the actual calibration curve obtained is shown in Figure 1 of this report.

The mean temperature rise above ambient obtained from three specimens is also shown in Figure 1 (i.e. with the actual calibration curve). The mean temperature readings for the material and the calibration curve were obtained at the following intervals from the start of the test: at 1/2 minute intervals up to 3 minutes, at 1 minute intervals from 4 to 10 minutes, and at 2 minutes intervals from 12 to 20 minutes.
